# Field-Testing and Optimizing UAS Transportation Infrastructure Inspection Methods

CTIPS-020

Approved 7/16/2024

Colorado State University

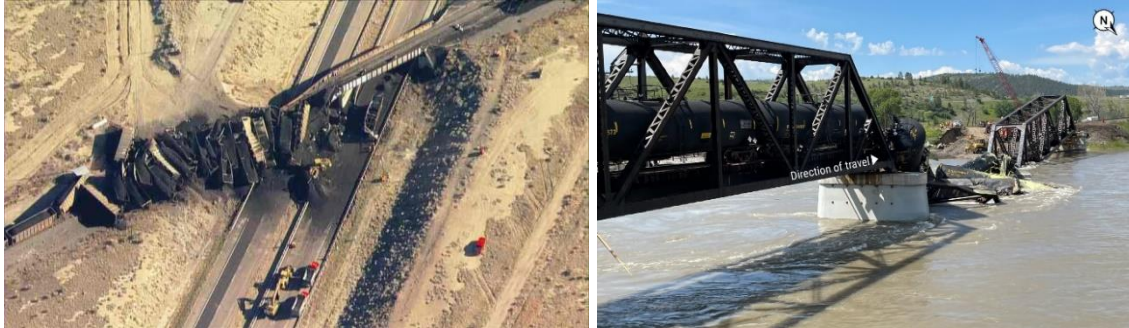
Figure 1. Two significant derailment failures: Left: 30 BNSF rail cars hauling coal near Pueblo, Colorado, derailed on October 15, 2023, causing extensive damage and one death on I-25 below the bridge (photo courtesy of KVDR); right: 16 rail cars, 15 of which had hazardous material, derailed on June 24, 2023 at Reed Point, Stillwater County, Montana (photo NTSB). In the former case, the tracks had been inspected on the day of the accident.

have sometimes proved inadequate. Figure 1 shows two railway line failures, including one incident where the tracks had been inspected multiple times in the weeks prior to the accident including one completed the same day as the accident. Part of the challenge comes down to manpower and resources.

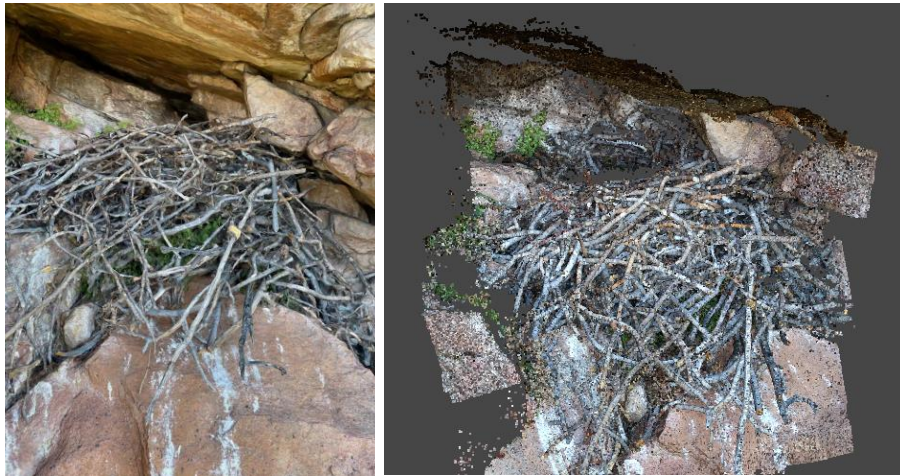
Figure 2. An example of imaging technology, differences in output, and imaging rates for a low-density fibrous composite (a raptor nest 200 feet off the ground). On the left is a still photo from a three-dimensional Lidar scan (which took under a minute to obtain) and the point cloud extension using SfM for the exact same nest but with 26 photos taken using a digital camera, which took about five times as long to obtain.

*Structure from Motion (SfM):* SfM is a photogrammetry method that uses digital images to recreate point cloud data that can be used to track damage growth or change. It can be especially useful to compare damage over a period of time by overlaying the resulting point cloud data to track and quantify differences or changes in geometry. An example of Lidar imaging compared with SfM data is shown in Figure 2.
